## SITE VISIT REPORT NO. 1

<b>Project:</b>	<b>ST. ANDREW'S CHURCH</b> <b>75 SIMCOE STREET, TORONTO</b>	<b>File No.:</b>	J003-001
<b>Owner:</b>		<b>Site Visit Date:</b>	18-Sep-08
<b>Contractor:</b>		<b>Report Date:</b>	20-Sep-08

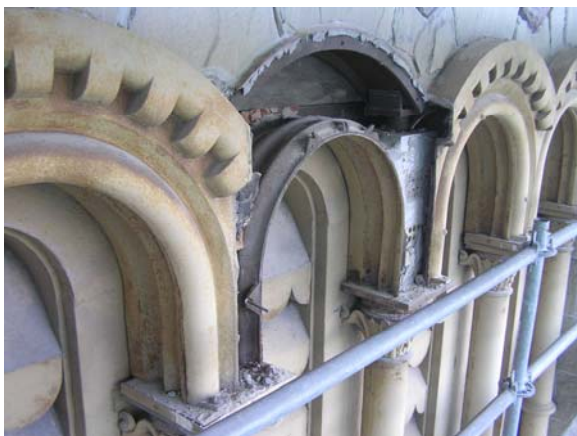
One arch with dentils was removed for inspection on south elevation. It appears that it was originally attached with 4 bolts to the underside of the arch, and with additional 3 bolts to the load bearing hidden arch.

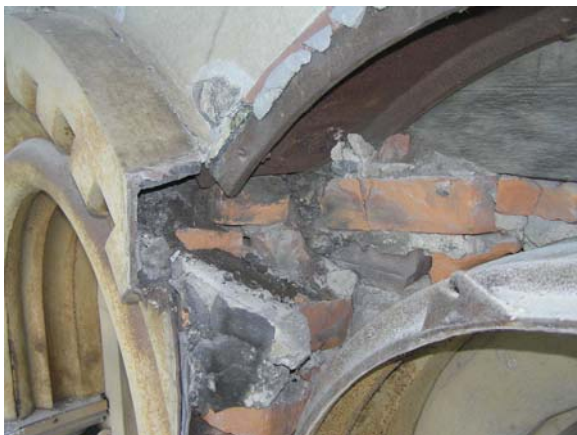
It appears that the load bearing cast iron arches were originally designed to rest on brick piers filled within four cast iron pieces: two on the sides and two front pieces (one is removed).

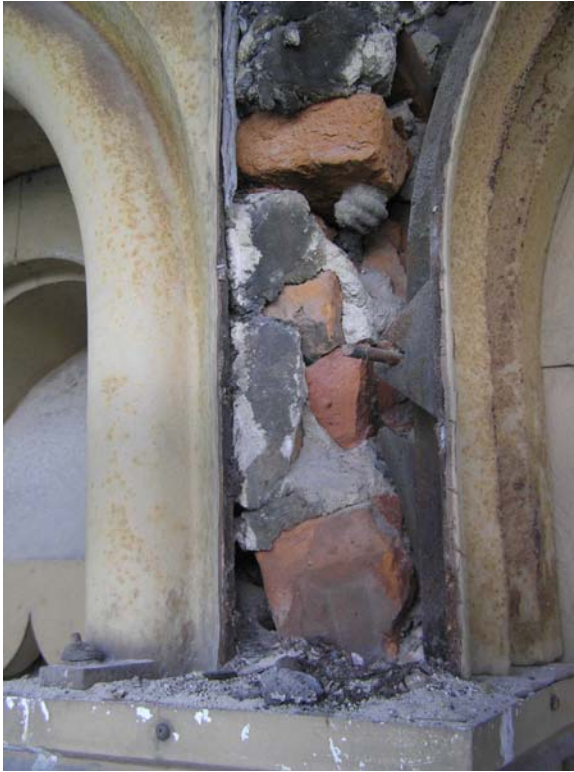
The poor quality of workmanship in constructing the load bearing brick pier is evident. One can only assume that remaining piers are of similar quality.

It appears that inner arches (the right-most one in the photograph) are not at all attached to the steel plate. The restoration of cast iron elements must address this deficiency.

The contractor shall carefully, without rebuilding, fill empty spaces with mortar and grout, as necessary. Softer lime based mortar with some Portland cement is recommended (Type "O" or similar, to be verified with project Architect).

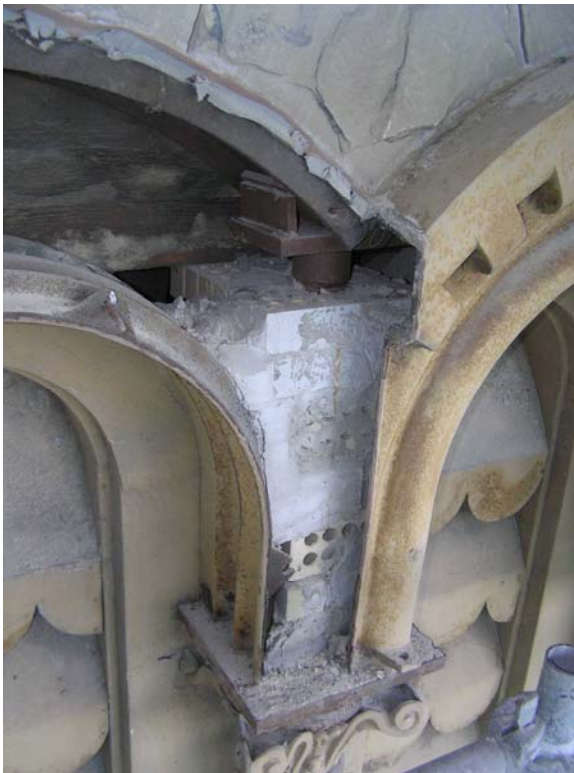
The other, east, side of the load bearing cast iron arch is supported on steel post encased in fairly contemporary looking brick.

The hole in right hand side dental arch is not aligned with the plate below, and this, and many other arches, is not attached to the plate.

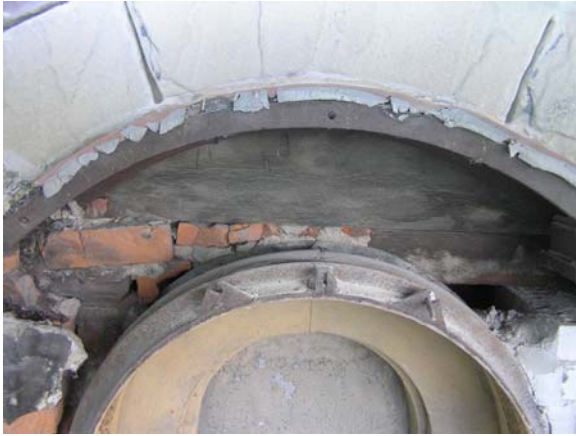
The load bearing arch has 3 small holes for bolts that connect it to decorative arch. It will likely be impossible to re-attach decorative arch to load bearing arch.

We recommend that two stainless steel through-bolts connect decorative arch to the big wood beam behind, using large washers and locking nuts on the interior face of the wood beam.

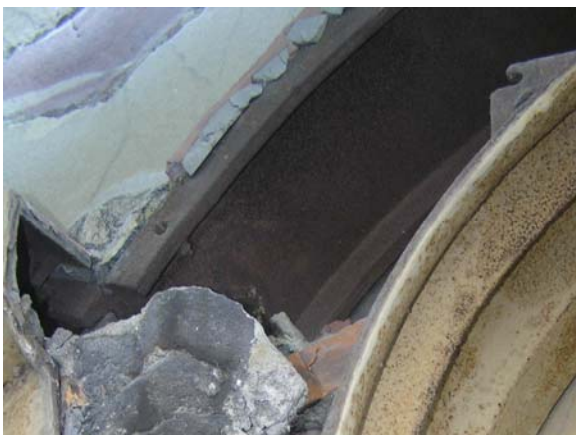
Please note one of three bolts that were connecting decorative arch to the load bearing arch.

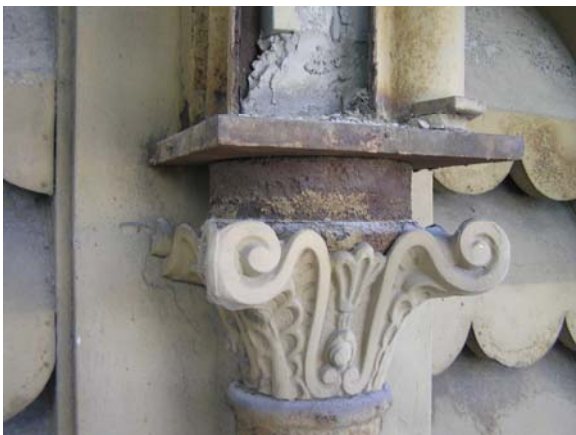
It is not clear how the top part of the column is attached to the lower part.

We are seriously concerned that there is no positive connection, and that the connection is actually a hinge. If this is true, then, theoretically, the existing column and arch system is not stable.

Detailed investigation and analysis of cast iron columns and arches is recommended before proceeding with any restoration work.

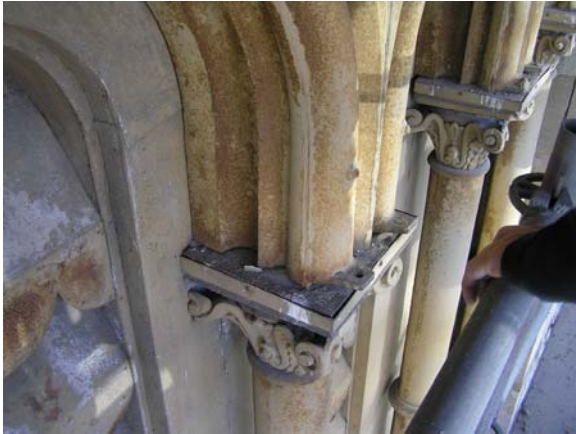
A few of the decorative arches are not connected to plates below.

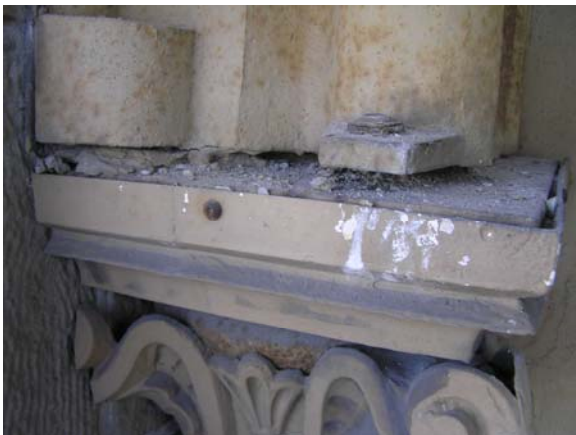
Even when there appears to be a bolt installed between the arch and the plate, the bolt is usually corroded or does not even exit between the L-plate and column capital plate. The fact that there is usually a gap between the exterior decorative cast iron elements and column capital plate indicate that the load is transferred either through steel (cast iron?) column, or brick pier of questionable quality, discussed above.

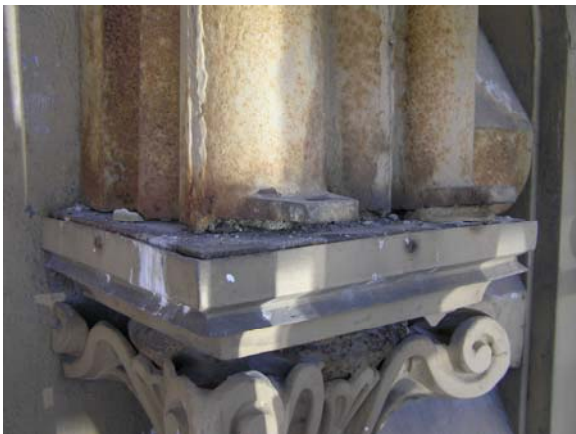
Another such example.

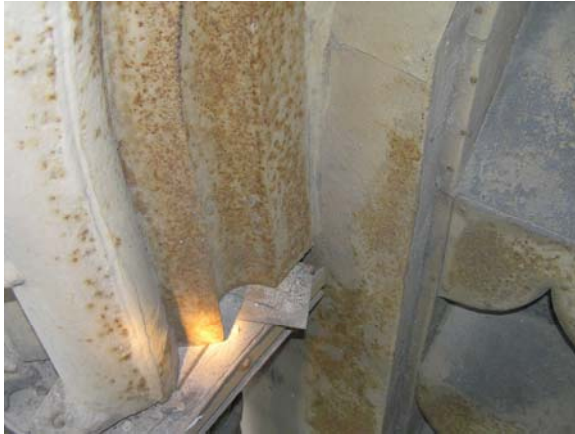
This and the following photograph show steel shim plates between the decorative cast iron elements and column capital plate. These shim plates are not original.

There was obviously some restoration of cast iron decorative arch structure in the past. The extent and quality of workmanship can not be assessed short of complete dismantling.

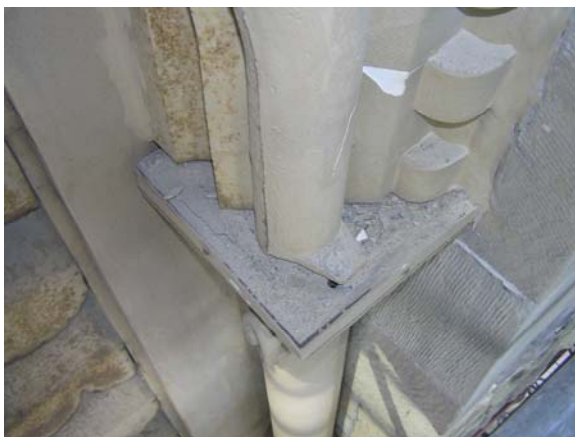
Please see description with the previous photograph.

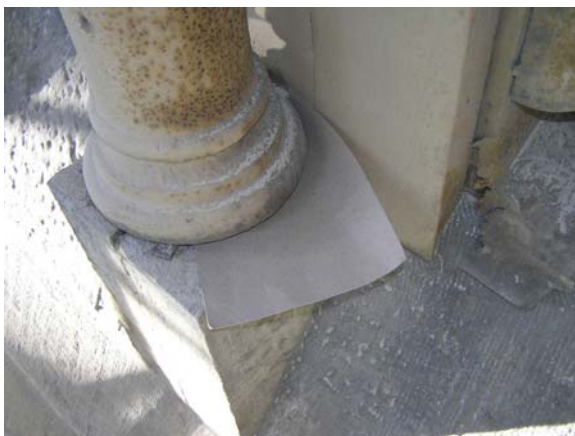
It is interesting to note that at several locations column base appears to be lifted from stone base. In this location, we were able to insert a sheet of 8 ½" x 11" cardboard (soft) as shown in photograph.

We are concerned that the columns are not positively attached to the stone base.

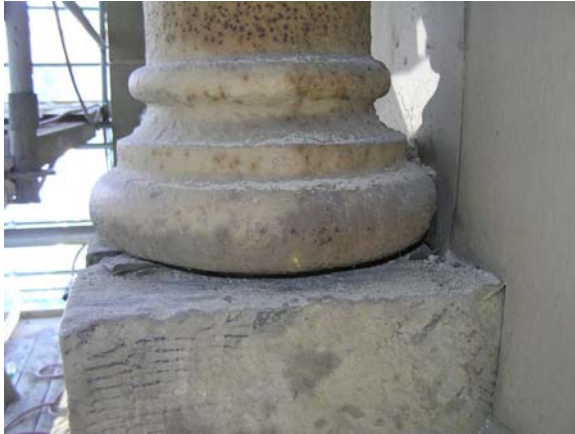
There seem to be some thin plates that could have been used to attach column to stone, but the gap between the two is evident.

We recommend further investigation of the whole assembly.

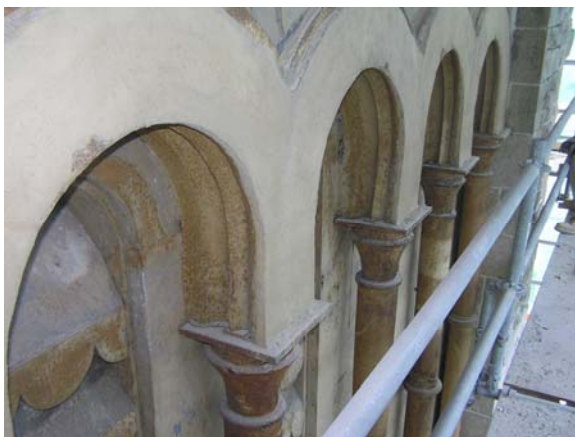
The west side arches do not include decorative exterior dental pieces, and the columns are simpler.

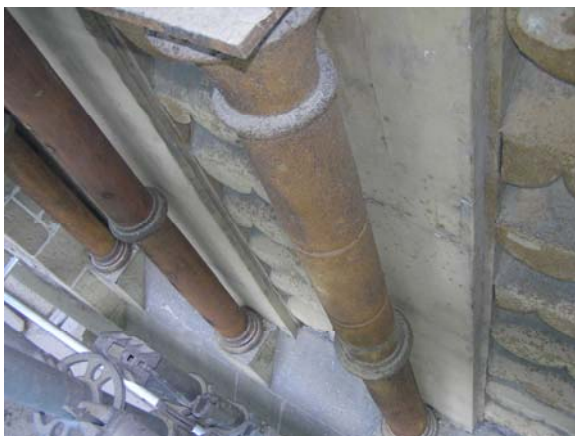
At least in two locations we observed sheet metal “bandage” on part of the column shaft, attached with two adjustable rings. This intervention could not be structural, but is worthwhile exploring further.

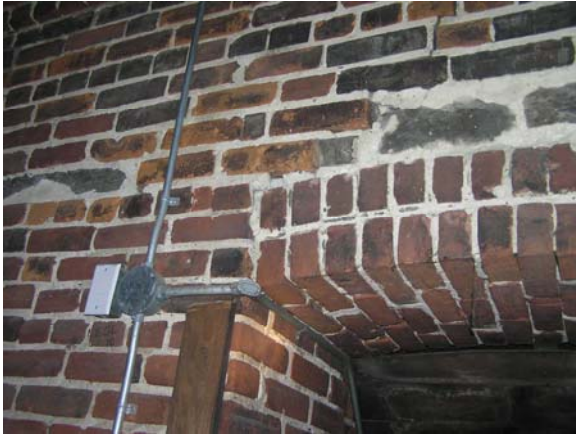
A crack has developed from the north end of flat brick arch at the top of stairs within the tower. We suspect that the crack may be a result of insufficient bearing of the brick arch of side walls. Please see also the next photograph with similar bearing condition.
